HS-802-103

PROOF PRESSURE EVALUATION OF WORN PASSENGER CAR TIRE CARCASSES

S. K. Clark
R. N. Dodge
D. W. Lee
J. R. Luchini

FINAL REPORT

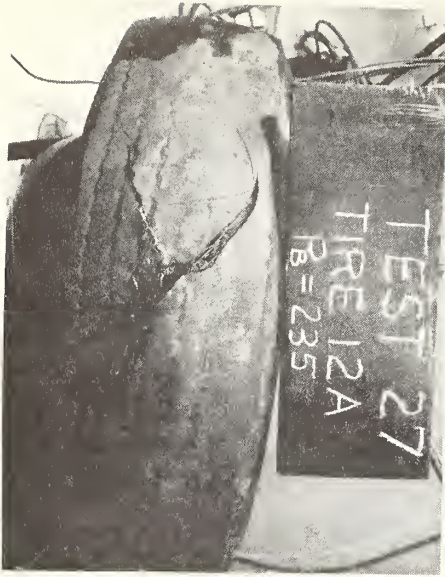
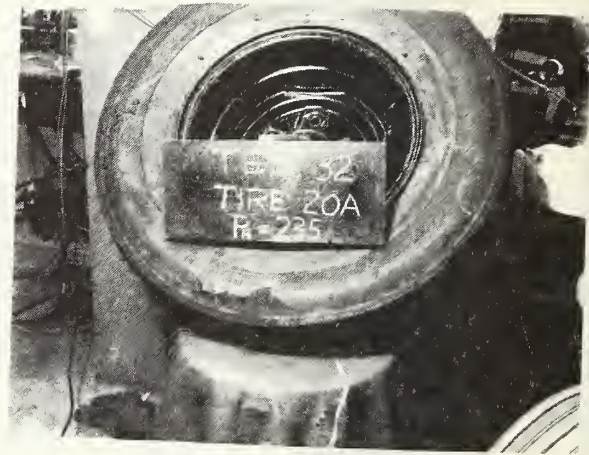
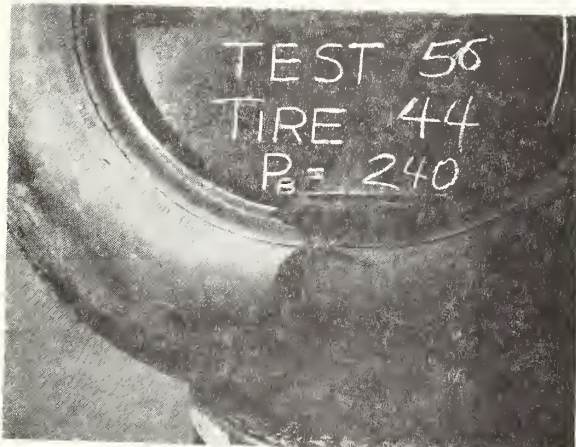
FIGURE 4. PHOTOS OF TYPICAL BURSTS

When the burst test was performed the type of failure was recorded. The failure modes were characterized as crown, shoulder, sidewall, or bead failures depending on the location of the carcass rupture. Photographs illustrating typical failures of the type mentioned are shown in Figure 4. On several occasions multiple failures occurred in a single tire, for example, both the crown and sidewalls having obvious ruptures.

Table 1 showed the distribution of failures over the various constructions considered. The trends were much more dramatic than expected. The two-ply bias tires tended to fail more regularly in the crown area, whereas the radial ply tires tended to fail most often in the bead. The other constructions were divided in modes of failure. The polyester-fiberglas bias-belted tires tended to fail most often in the crown, while exhibiting some bead failures. In contrast, rayon-rayon belted-bias tires tended to fail most often in the sidewall, while exhibiting some failures in the bead. For the four-ply tires, failures seemed to be equally balanced between bead and crown failures.

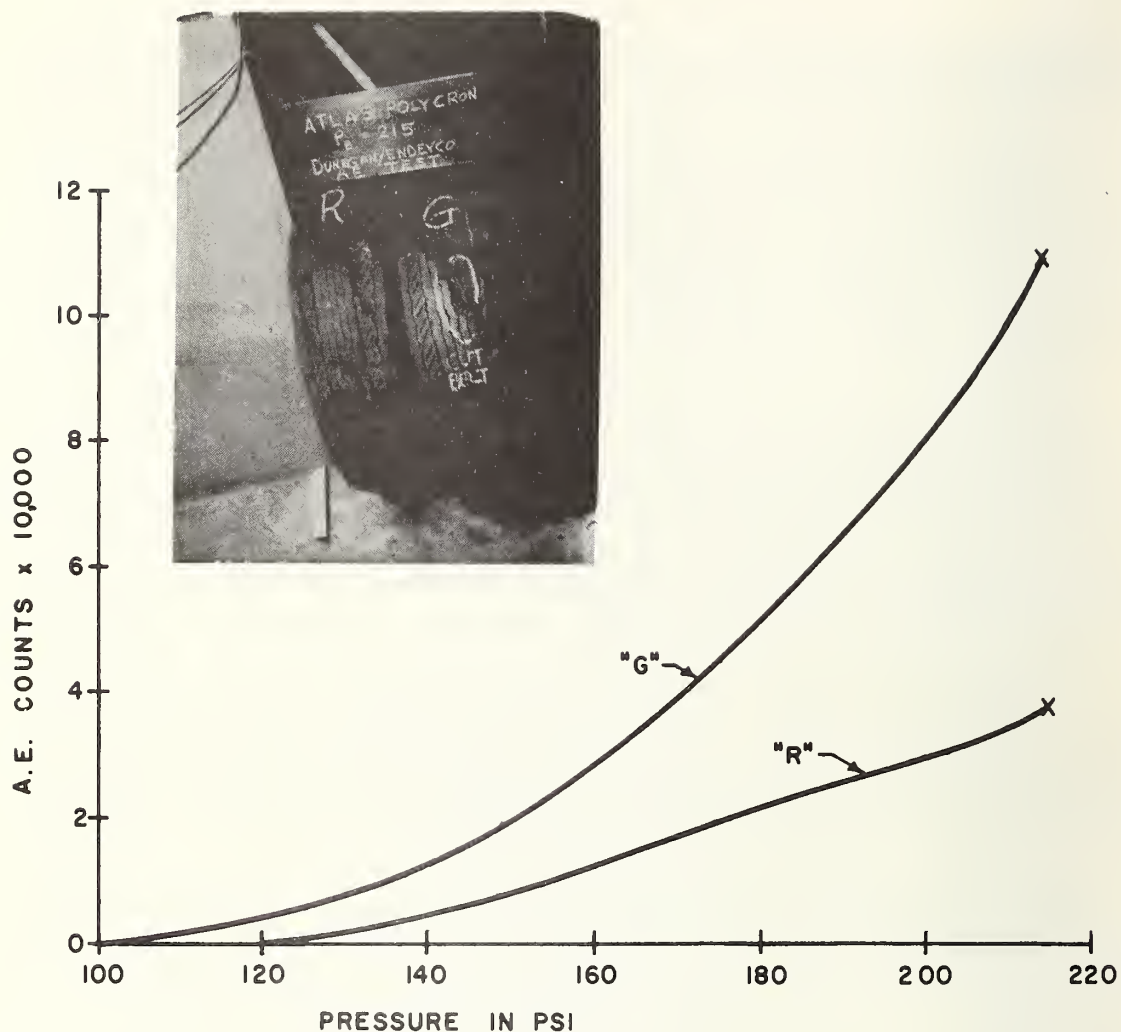
FIGURE 7. ACOUSTIC EMISSION OUTPUT FOR TWO IDENTICAL TIRES:
TIRE "R" UNDAMAGED; TIRE "G" WITH CUT BELT

Two pairs of tires are of particular interest. One pair of polyester-fiberglass bias-belted tires of identical size, manufacture, and wear were burst. One tire was known to have a damaged belt. The graph of the A.E. output from the two tires in Figure 7 shows the damaged tire (marked "G") began A.E. at a lower pressure and produced more than twice the A.E. of its mate. Although the failures were identical, it should be noted that both tires would have withstood hydrostatic pressurization even though one was clearly damaged.

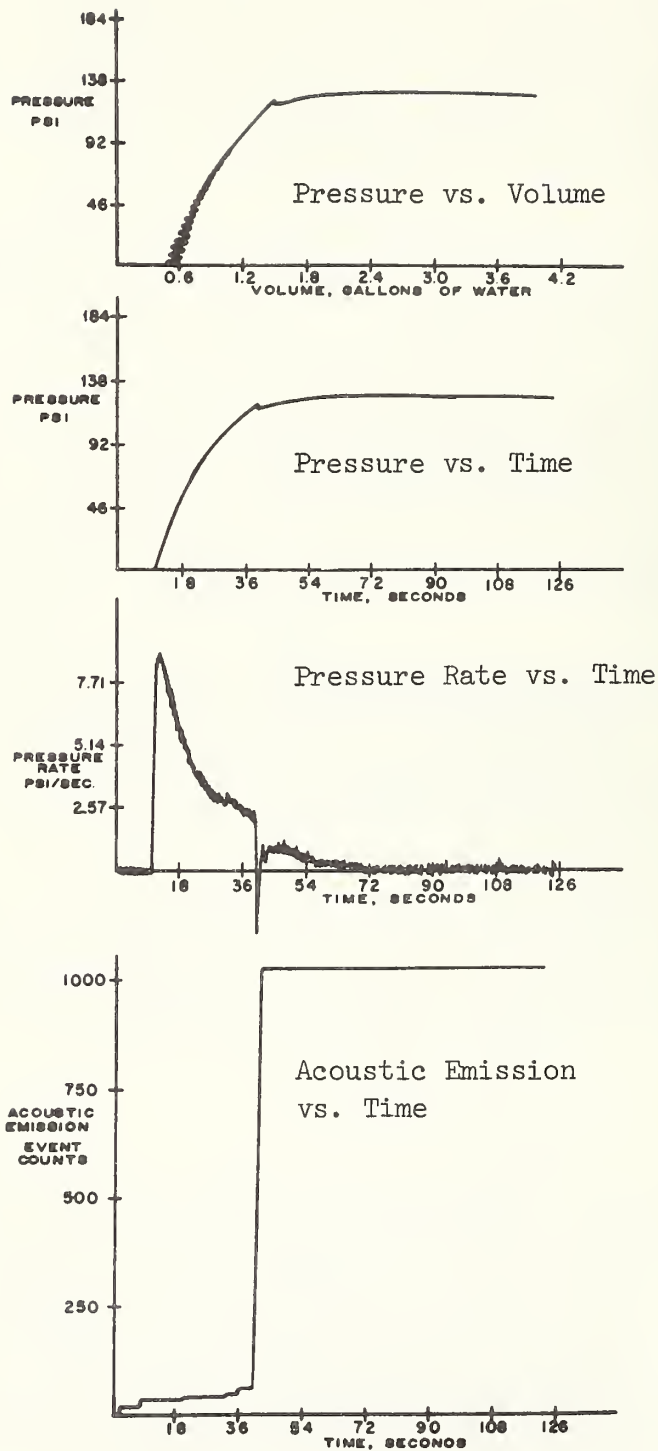
FIGURE 12. DATA FOR 6.45 X 14 TWO-PLY POLYESTER—LEAK

The sets of data shown in Figures 12 and 13 illustrate the only flaw that seems detectable from these records, a leak in the tire. The tire in Figure 12 developed a leak about 120 psi while a similar tire shown in Figure 13 had no flaws. As can be seen from these two figures the plots for the tire with the leak are distinctly different than those for the tire with no leak. Also it is of interest to note that all of the plots in Figure 12 clearly indicate the occurrence of the leak.
